## NHS PQAC Medical Gases Information & News

### NHS PQAC Advice Note

### Transporting calibration gas cylinders in your car; necessary but is it allowed?

# Piped Oxygen line punctured at an NHS Hospital

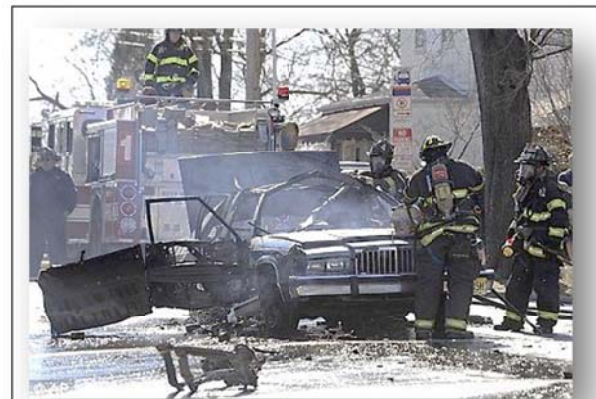
Firemenwork on a car after it exploded and burned in Hackensack, New Jersey February 2012

An 82 year-old smoker with emphysema, caused a massive car explosion after lighting cigarette in a car beside SEVEN oxygen tanks. Three consecutive explosions occurred and four people were injured in the blast. The top of the car was blown off and landed 50 feet away, all that was left of the car - a 1987 Mercury Grand Marquis - was a charred frame.

- **Keep the car well ventilated.** Open a window and set the ventilation to allow air to enter from outside to ensure the car is well ventilated
- Never smoke (or allow anyone else to smoke) when carrying oxygen in the car (See panel across)
- Carry gases properly stowed and locked in the boot. Cylinders should be secured with a cargo net or similar
- Ideally, your vehicle will be equipped with a dry powder fire extinguisher in good working order

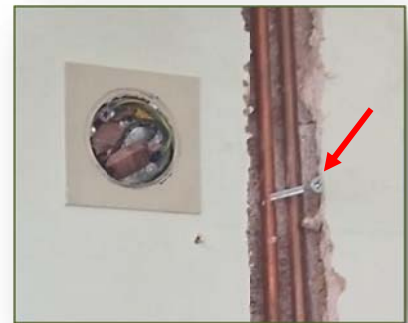
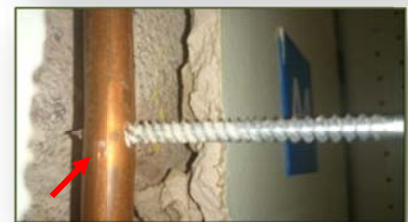
The Estates personnel turned up fairly promptly and proceeded to drive a screw into the wall. They had not thought to test for any wiring or pipes that could be behind the plasterboard. The screw went through the plasterboard and then a loud hissing sound was heard.

From the close-up of the pipe you can see that the Estates chap had grazed the pipe on the first go, pulled out and went straight in the second time..... and what a screw!

As patients were actively being treated with oxygen, it was agreed not to isolate the pipeline until cylinder replacements had been brought in. After the patients transferred to this supply, the pipeline was isolated and the pressure bled down. The team then waited for 5 minutes before proceeding, in case the wrong pipeline had been isolated with potential consequences for other patients. (A lesson learnt from our previous 'Advice Note' and the national MedGas refresher day) Nothing untoward happened, so the pipeline was purged.

The repair was difficult as space was tight and no shielding could be done. The CP used a high temperature torch, protected the wall with asbestos and doused it and the plasterboard with generous amounts of water.

- **Ensure drawings for the medical gases pipeline were updated to reflect the current, actual installation**
- **Consider reconfiguration of the pipework so that additional valves can be put in place to enable isolation of individual bays**

**And to the workmen – use your detector!**
